Third Five-Year Review Report

**Arkwood, Inc. Site
Boone County
Omaha, Arkansas**

July 2011

**Prepared By
Region 6**

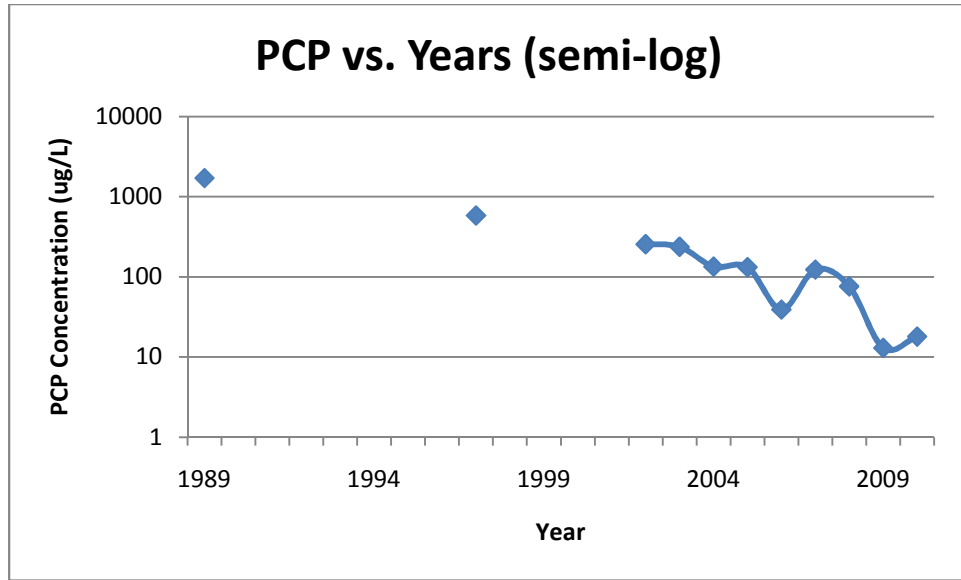
Figure 2b
New Cricket Spring
PCP Concentrations – Semi-Log
1989-2010

2006 \approx 39
 2007 \approx 123
 2008 \approx 76
 2009 \approx 13
 2010 \approx 18

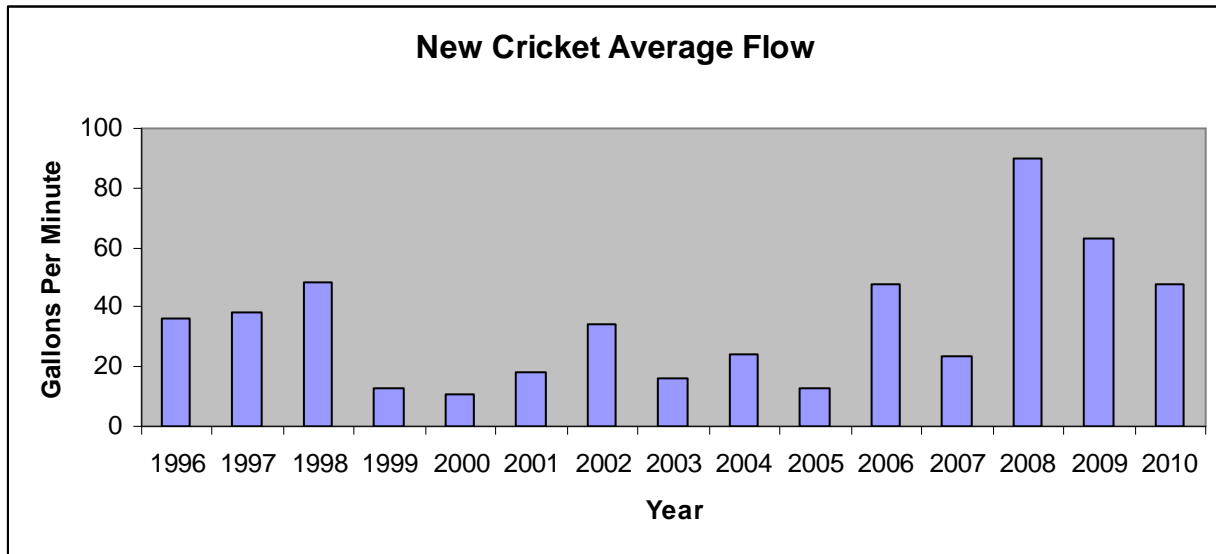
Figure 3

The volume of water flow at New Cricket Spring has been measured over the past fifteen years. Flows vary from less than 1/2 gallon per minute (gpm) to over 1,000 gpm.
